UKMHA

Safety Alert

Alert No: 0001
Date: August 2022

Disconnected Hydraulic Line

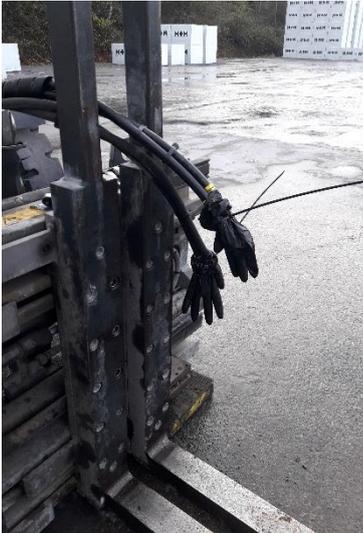
- **Inadequate equipment:** Improvised measures, such as the use of nitrile gloves and cable ties to capture drips from hoses, are inadequate.
- **Assessment of risk:** Continuously monitor for hazards introduced after work commences. Trip and slip hazards should be addressed before proceeding.
- **Management responsibility:** This is a reoccurring issue; therefore, managers and supervisors should take appropriate steps, including:

- Oil spills result in an **immediate hazard** and must be cleaned up before continuing with the job.
- Temporary hose blanks should be fitted to reduce oil spills whenever hoses are disconnected unless self-sealing quick release couplings are present.
- Hose blanking plugs should be included as part of the engineer's equipment.
- Spill kits should be available in the immediate vicinity when working on hydraulic systems.
