Jacking and Blocking

Incident Description:

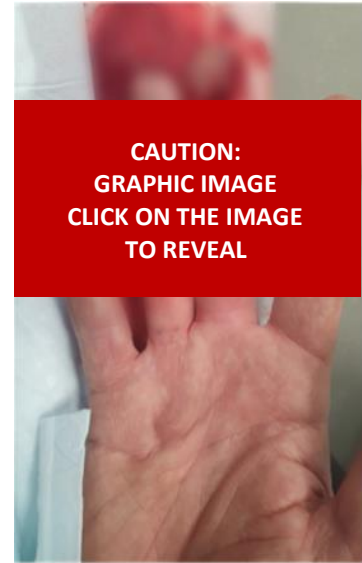
The engineer jacked up a reach truck to check for free play in the steering bearing fitted to the top of the final drive gearbox. The truck was not lowered onto supporting blocks, leaving the jack as the only load support for the task. The engineer held on to the drive wheel in order to check for excessive play in the bearing. The truck slipped off the jack and trapped the third and fourth finger of the engineer's right hand between the wheel and the floor. The resulting injuries included cuts, crushing and fractures.

- **Inappropriate Equipment:** The truck was only supported by the jack at the time of the incident. It should have been sitting on supporting blocks with the jack removed.
- **Training:** The engineer failed to recognise the hazard of working on a truck only supported by a jack.
- **Safe Working Area:** The engineer's service van was parked too close to the truck, restricting access to the supporting blocks that were in the van.
- **Job Planning:** The task was being carried out after the original job had been completed and without first carrying out a point of work risk assessment.

- **S - Stop**
- **T - Think**
- **O - Organise**
- **P - Proceed**
- Establish a safe working area.
- Carry out a risk assessment and check the truck service manual.
- Ensure that the required tools and equipment are available.
- Follow an established Safe System of Work.
- Lower the load onto suitable blocks in the approved locations.
- Remove the jack.

Do NOT work under any load that is supported by a jack.
